Open Sea Operating Experience to Reduce Wave Energy Costs

Deliverable D1.2

Mutriku and BiMEP operating data collection experience

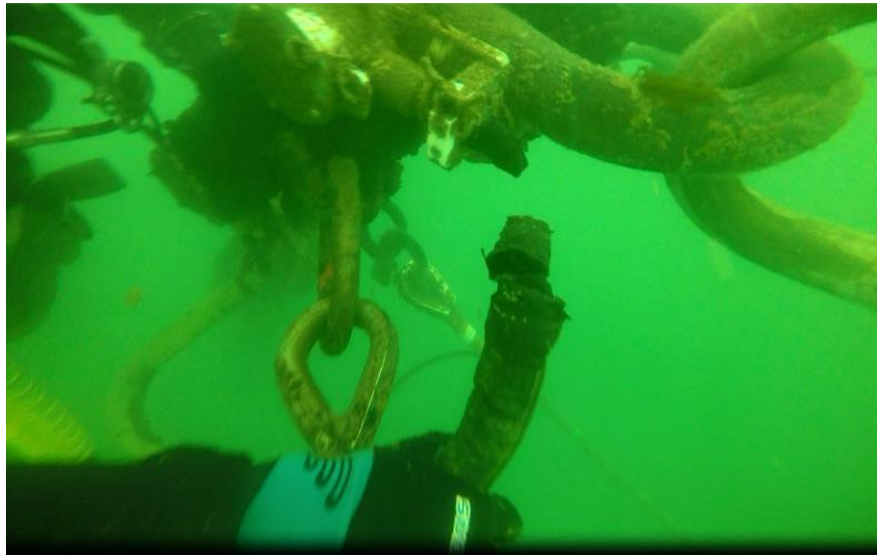
FIGURE 2-5: DETAIL OF THE LOAD SHACKLE ELECTRIC CABLE BRAKE

A more robust wiring should have been implemented in order to resist the force the waves imposed to the connectors. In a possible new implementation, the wirings should be protected more consciously.

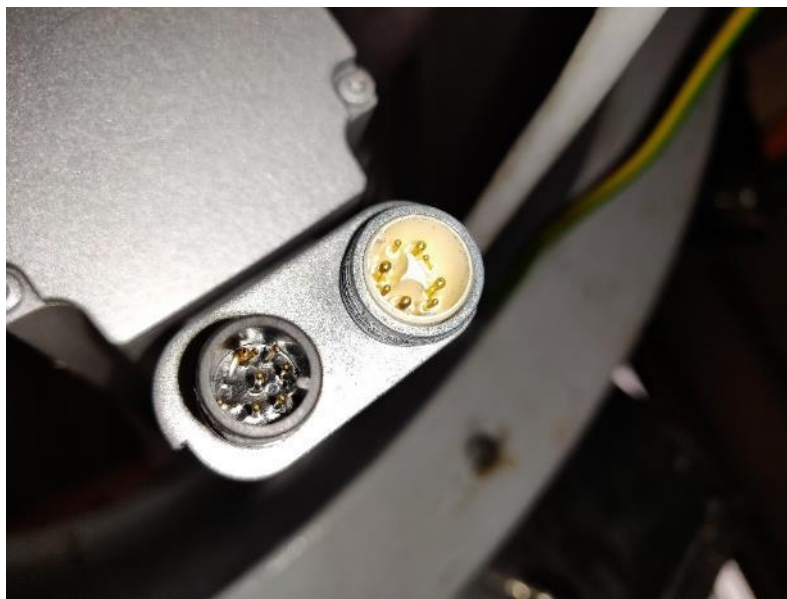
FIGURE 2-7: CONNECTORS OF THE HSSV VALVE

During the last period of tests, some hardware failures were also detected, where some actuators would randomly raise errors and trip either during their homing process or during valve operation. Further investigation showed that hardware errors were caused by the faulty valve connectors. The connectors of the actuators are very fragile considering the harsh environment where they must operate, especially the encoder connectors. The connector plug-in process, even if carried out carefully, can result in damage in the actuators connectors. A more robust actuator should be chosen for this application in next designs.

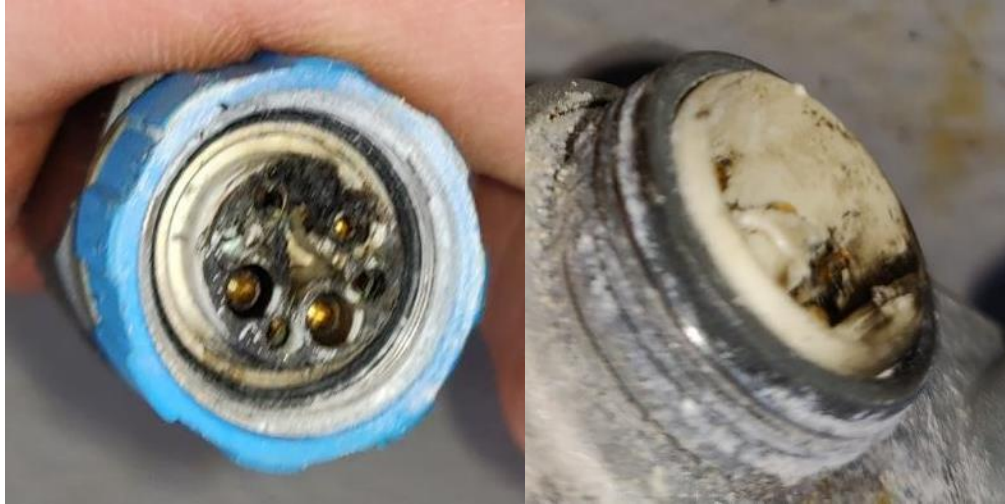
FIGURE 2-8: POWER CONNECTOR AND PLUG OF HSSV ACTUATOR

In March 2019, during some commissioning tests, an electrical failure caused the valve to stuck open with the turbine rotating freely. The attempt to take control on the generator was made, but an overcurrent in the HSSV cabinet tripped the U UPS system, leaving the buoy in blackout situation. This led to a loss with the buoy communication with the HSSV open, and the air flow spinning up the turbine. It was only due to the fact that the buoy was being operated from BiMEP's local offices that it was possible to make a fast trip to the buoy to manually stop the system, ensuring that the turbine didn't accelerate over the high-speed safety limit. Ultimately, decision to maintain the release valve open during the commissioning was also crucial, preventing all the air flow from going to the turbine and accelerating it to a speed where its integrity would have been compromised.

Further diagnosis determined that an electrical problem caused the actuator to fail and the HSSV to get stuck in open position. FIGURE 2-8 shows the state of the power connector and plug of the actuator. The probable cause of the electrical failure was identified a faulty connector that created a hot-spot in the connector, ultimately leading to its overheating.

Soon after the damaged actuator and power cable were replaced, some new problems appeared. These problems were related to the encoder connection of the actuators.

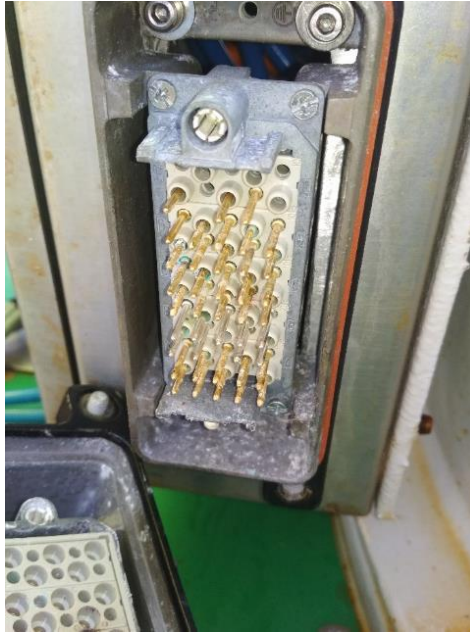
FIGURE 2-9: HSSV ACTUATORS WEIDMULLER INTERMEDIATE CONNECTION

This intermediate connection had to be installed in the power and encoder cables between the HSSV actuators and the drives of this actuators located inside the buoy. This connection was made using Weidmuller Rockstar connectors with the aim of facilitating the commissioning works of the turbine and its adaptation to the existing MARMOK-A-5 wiring systems. However, the harsh environment caused corrosion to build-up on these connectors. A bad connection due to rust could be probably the cause of the errors encountered.

To solve the issue, a direct connection from the actuators and the drives was implemented, using 15-meter length cables, bypassing in the intermediate connection. The cables were passed through the connection box using cable glands. The Roxtec connectors were used to pass insert the cables inside the buoy. Additionally, EMI/EMC filters were installed in the servo drives, as this was recommended by the drives manufacturer to reduce possible noise interferences.

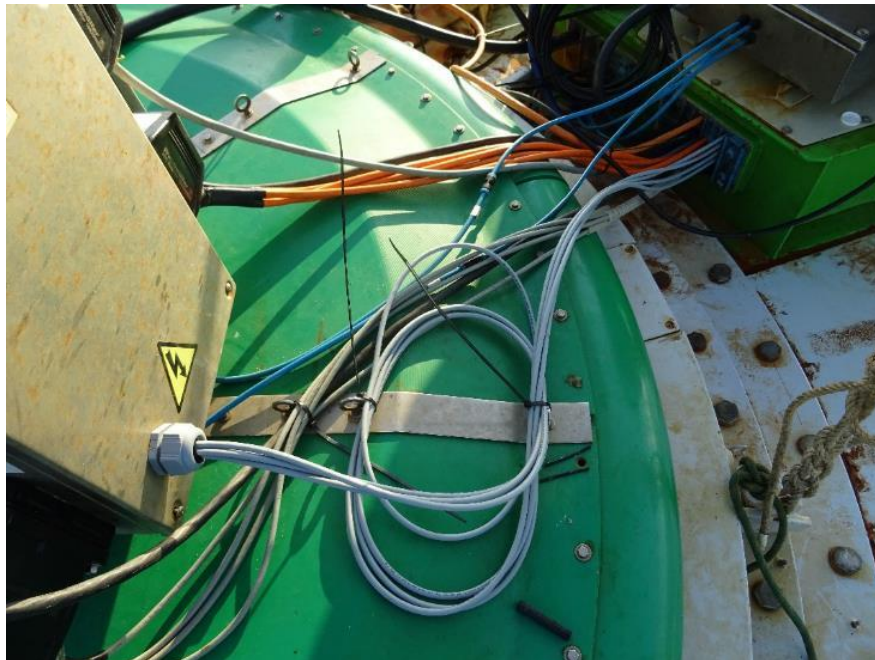
FIGURE 2-10: ENCODER CABLES DIRECT CONNECTION THROUGH CONNECTION BOX AND ROXTEC

These actions solved the encoder errors, however, soon after, new problems emerged in the HSSV valve.

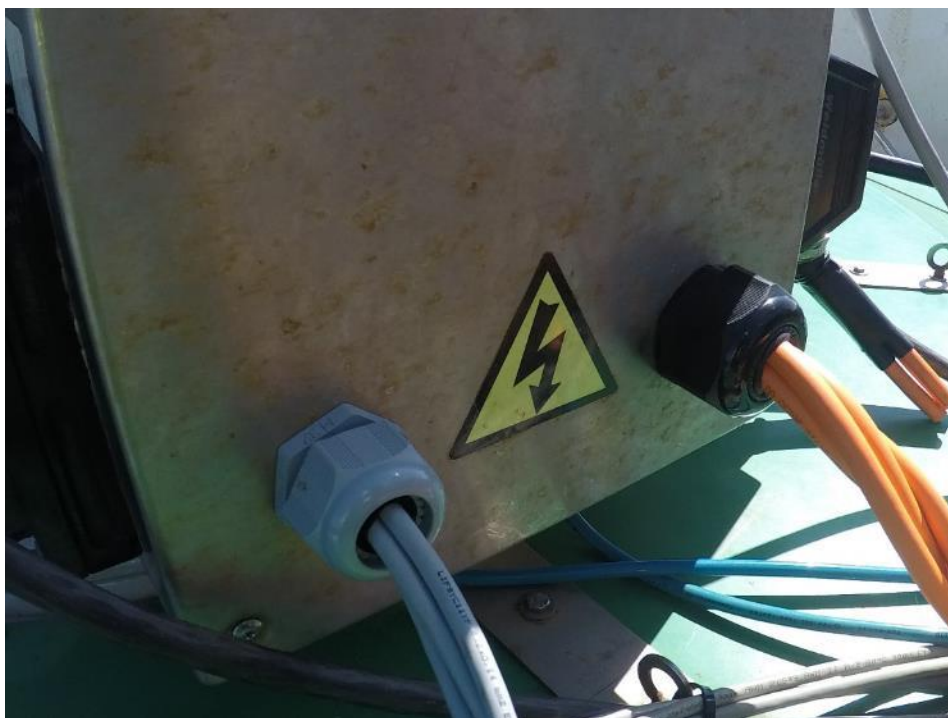
FIGURE 2-11: CABLE GLANDS IN CONNECTION BOX FOR ENCODER AND POWER CABLES

During a heavy storm, and only two days after the encoder problem was solved, another actuator was damaged. Again, a shortcut error arose in the drive of the actuator number 1, and as had happened before, the actuator power connection was damaged, apparently due to an overcurrent.

With the testing campaign near its end, the decision was taken to bypass the terminal box again a route power cables directly from the drives to the actuators, using a direct connection, with 15-meter-long cables.

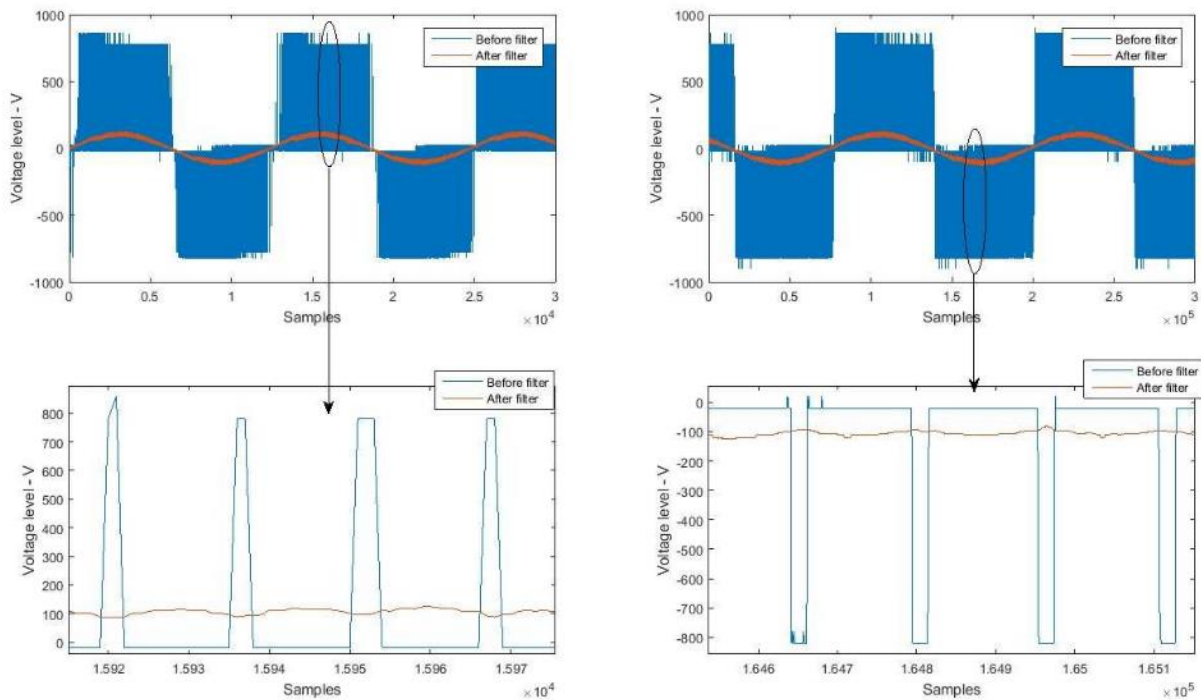
FIGURE 2-12: GENERATOR POWER VOLTAGE SIGNAL

A fault in the generator caused an early damage in the machine on September 2017 that ultimately led to stopping the test until the problem could be solved. The installed generator was not equipped with the correct degree of electrical insulation protection of the stator, which is typical of applications where the motor is fed by a Variable Frequency Drive.

The chosen generator was not appropriate for a Pulse Width Modulation (PWM) based inverter feeding as the power signal of FIGURE 2-12.

The isolation of the stator could not cope with the chopped power input of the machine and a shortcut damaged completely the stator of the motor. Two actions were taken to deal with this problem:

- On one side, a new stator was reinstalled in the generator. This new stator incorporated a reinforced insulation to avoid possible new damages produced by the same cause. The procedure of extracting the generator from the turbine and reinstalling it in its position was a complex task, due to the tight fitting of the generator inside the HSSV supporting structure.

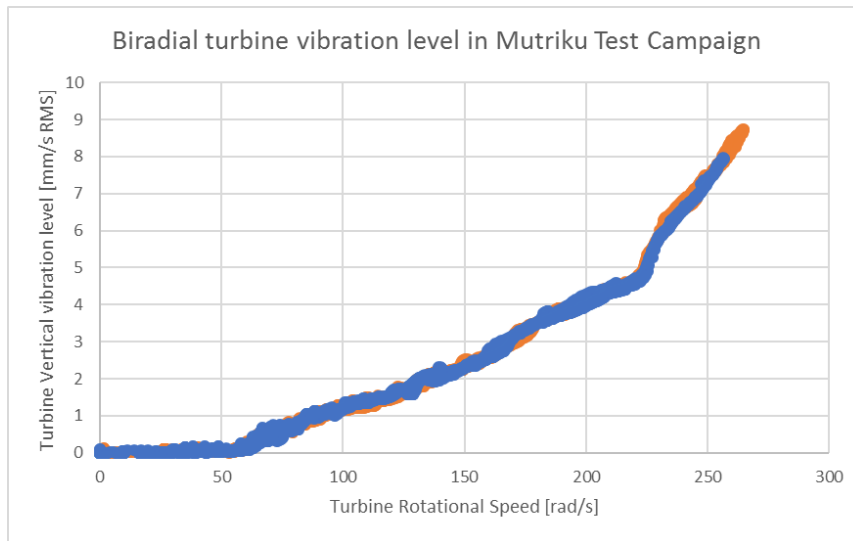
FIGURE 2-14: SIEMENS IM GENERATOR INSIDE THE TURBINE NACELLE

The vibration sensor equipped in the turbine during their dry-lab phase in Lisbon did not provide a meaningful reading. They provided acceleration RMS reading while rotary machine standards are generally expressed in mm/s. This led to the need to replace the sensors during the turbine commissioning in Mutriku.

The vibration values were measured in the turbine during normal operation and can be observed in FIGURE 2-14:

The mechanical coupling and the overall fitting of the generator to the turbine rotor was later revised prior to its installation in the MARMOK-A-5 and vibration levels were improved.

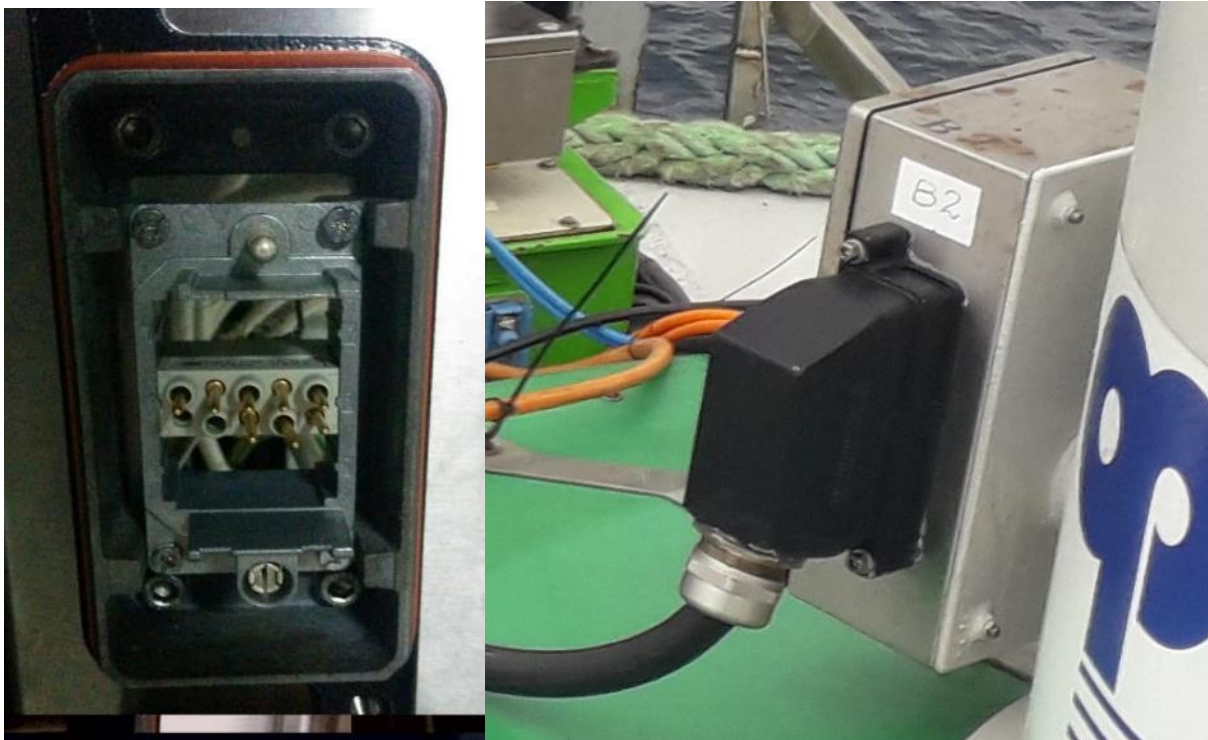
FIGURE 2-15: WEIDMULLER ENCODER AND POWER CONNECTION

However, the connection of the power cables required substantial work. The 35mm² section cables used to feed the generator were complex to manipulate due to their low flexibility. The force produced due to the rigidity of the cables made them hard to introduce inside the connector holes and broke in some cases the eyelash that holds the connector pin in position.

The installation of a more flexible cable would facilitate the setup for the power connector. A different kind of connector could also be chosen as the power cable was already installed in the test site.

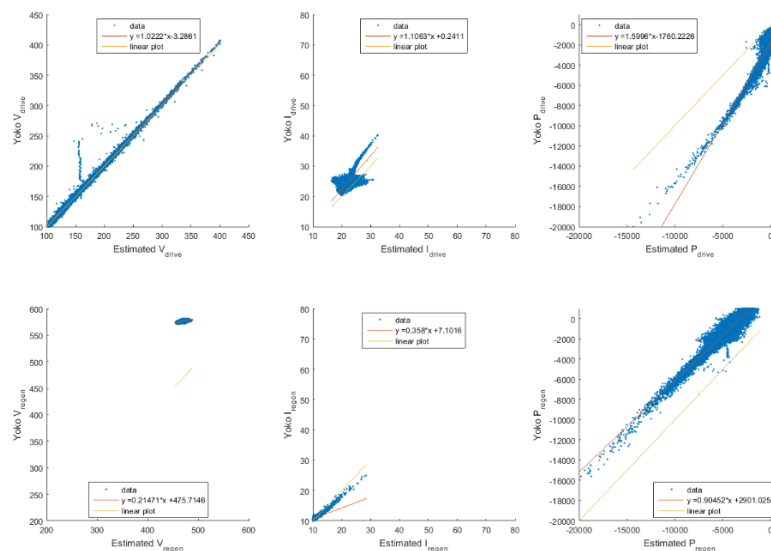
FIGURE 2-17: POWER ELECTRONICS POWER READING VS WATTMETER'S READINGS AS IN D4.2

The power electronics worked perfectly during the Mutriku test campaign. However, uncertainties in the power measurement resulted in significant extra effort in assessing the real electrical magnitudes coming from the generator mounted in the biradial turbine. The measurements by the Unidrive are not accurate, as they are only intended to represent approximate values, and incorporates significant errors depending on the load applied.

This could be solved using a true RMS power measurement equipment, like a wattmeter, but the installation of this equipment for the duration of the complete test period was not feasible.

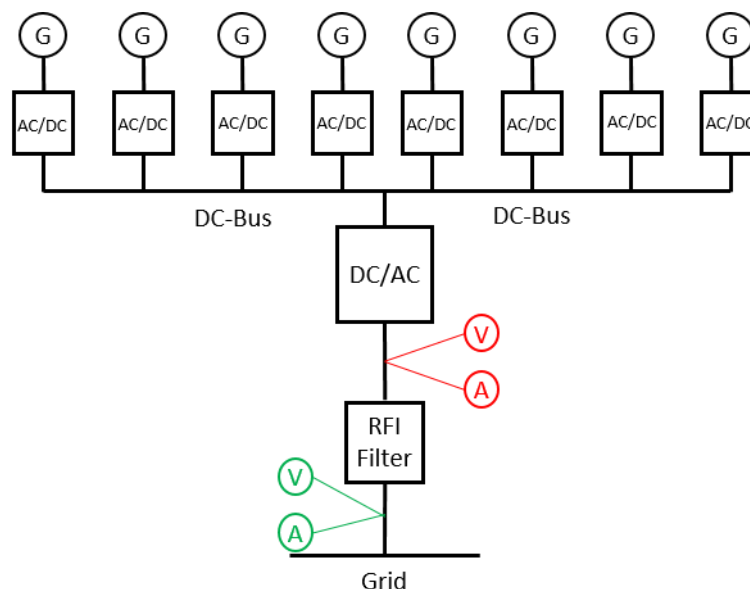
FIGURE 2-19: SINGLE LINE DIAGRAM OF USED MEASURING POINT (IN RED) AND THE MEASURING POINT RECOMMENDED BY TS (RED)

The voltage and current transducers were retrofitted into the already operational MWPP, and there were difficulties with the physical placement of the current transducers due to space and wiring requirements. Ideally, the voltage and current measurements for the application of IEC 62600-30 should be taken after the RFI filter that is used to remove the high frequency signal generated by the VFD in renewable energy generation systems. Unfortunately, the space and wiring requirements forced the installation of the transducers between the RFI filter and the grid-side VFD, and this influenced the results of the testing. FIGURE 2-19 is a single line diagram for an individual DC-Bus of the plant, which shows the ideal placement of the voltage and current transducers in green and the actual placement of the voltage and current transducers in red.

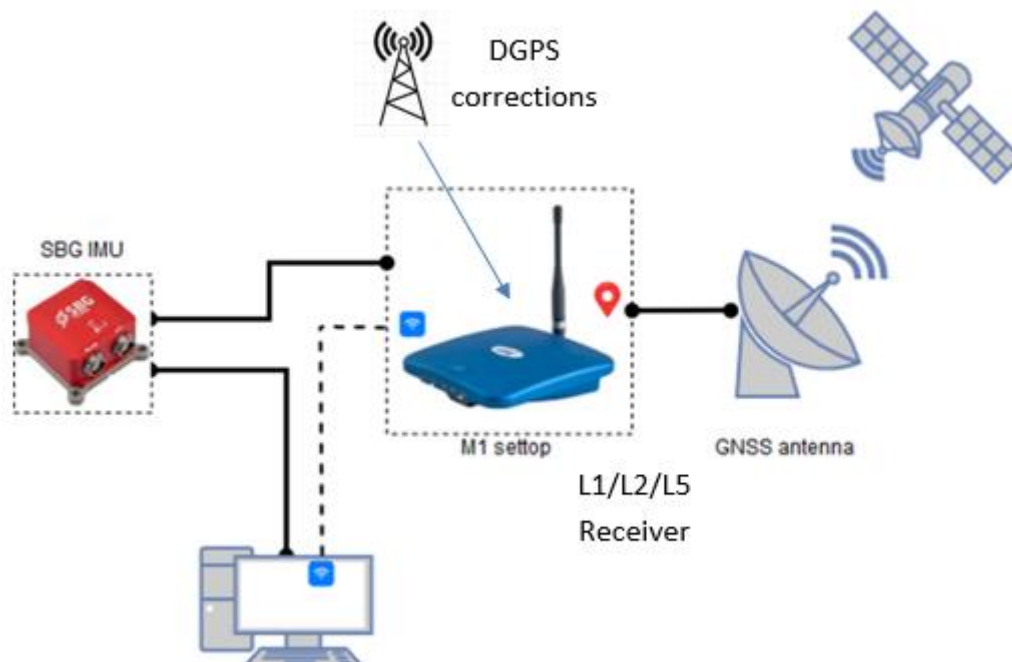
FIGURE 2-21: 6 DOF IMU SENSOR CONFIGURATION DURING DRY TESTS

Six Degrees of Freedom (DOF) of the buoy are monitored and stored online using an Inertial Movement UNIT (IMU) sensor and the help of a Global Navigation Satellite System (GNSS) antenna. During data analysis, uncertainties in the registered data concerning the yaw angle rose, detecting a non-constant drift in the yaw measurement.

A series of dry tests of the position monitoring system were performed in IDOM's offices to identify the possible source of the problem. The tests threw that the yaw value is measured using a gyroscope, which naturally measures angular rotation velocity, that needs to be integrated over time to obtain the angle value. This produces an intrinsic error that will be accumulated over time in the computed solution, producing a drift in the measured value.

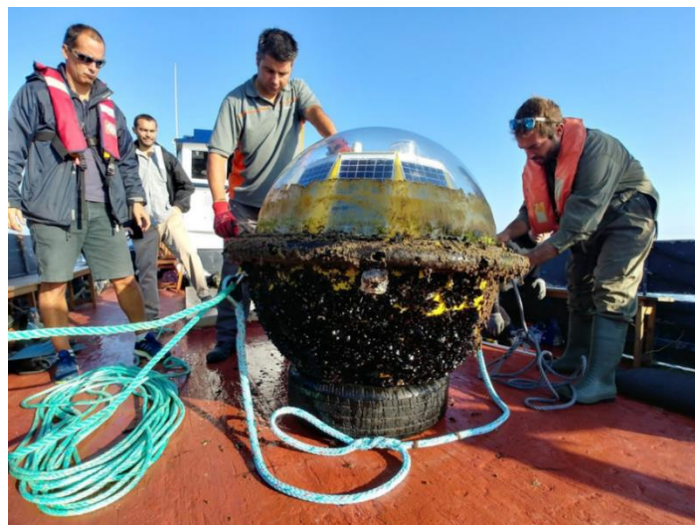
FIGURE 2-25: RETRIEVAL OF TRI-AXYS BUOY FOR MAINTENANCE WORKS

This operation was completed with a multipurpose ship, using a crane to extract the buoy from the water. The operation was completed by divers. The buoy was cleaned and opened to extract the data, and unfortunately circuitry inside the environmental buoy was damaged during this operation.

The reparation of the damage required 2 months, with the buoy kept in a dry workshop, and in the beginning of 2018 the buoy was finally re-installed again and was in continuous operation until the end of 2018.

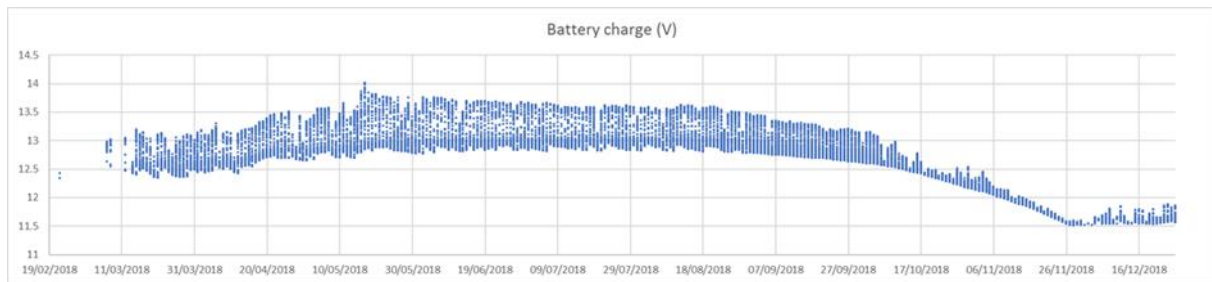
FIGURE 2-26: TRIAXYS BATTERY VOLTAGE ALONG 2018

At this stage the batterie's performance started to deteriorate. The graph below shows the slow but steady decay of the battery voltage levels during Fall 2018. Unfortunately, this overlapped in time with the deployment and the commissioning of the wave energy converter.

With the aim of mitigating this lack of good quality environmental measurements, BiMEP's Fugro buoy was taken into consideration of a secondary source of wave climate measurement. This would cover with good quality data a period ranging from last three weeks of 2018 to the end of January, where a storm also damaged this buoy. The decision was taken to take out the Tri-axys buoy for battery replacement and to install a third measurement instruments while its reparation, this time from the Basque company Zunibal.
