## Open Sea Operating Experience to Reduce Wave Energy Costs

### **Deliverable D3.3**

Turbine and electrical equipment performance and reliability  
in shoreline OWC wave plant

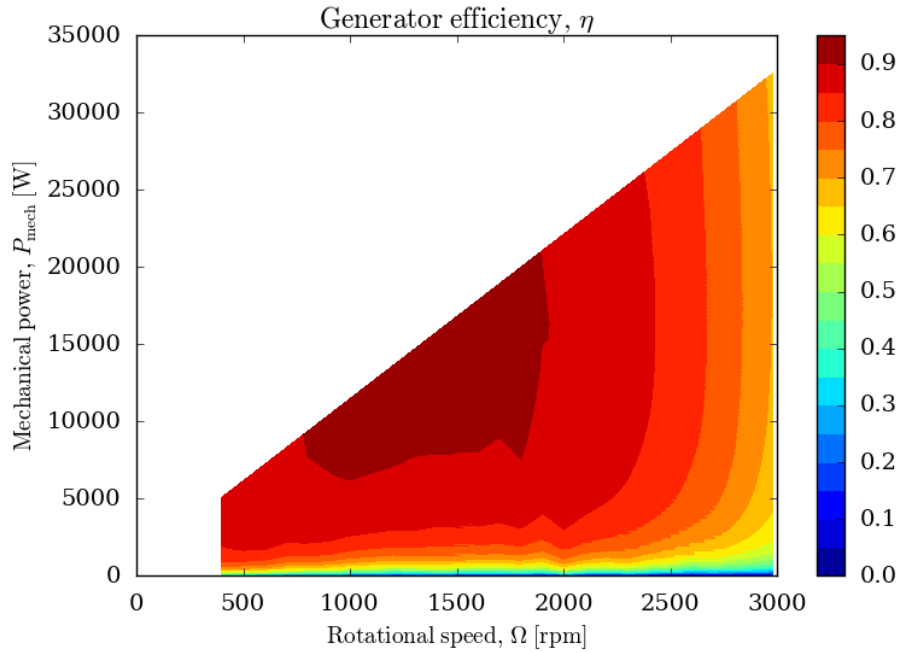
**FIGURE 5. CONTOUR PLOT OF THE GENERATOR EFFICIENCY,  $\eta_{gen}$ , AS FUNCTIONS OF THE ROTATION SPEED  $\Omega$ , AND MECHANICAL POWER  $P_{mech}$ .**

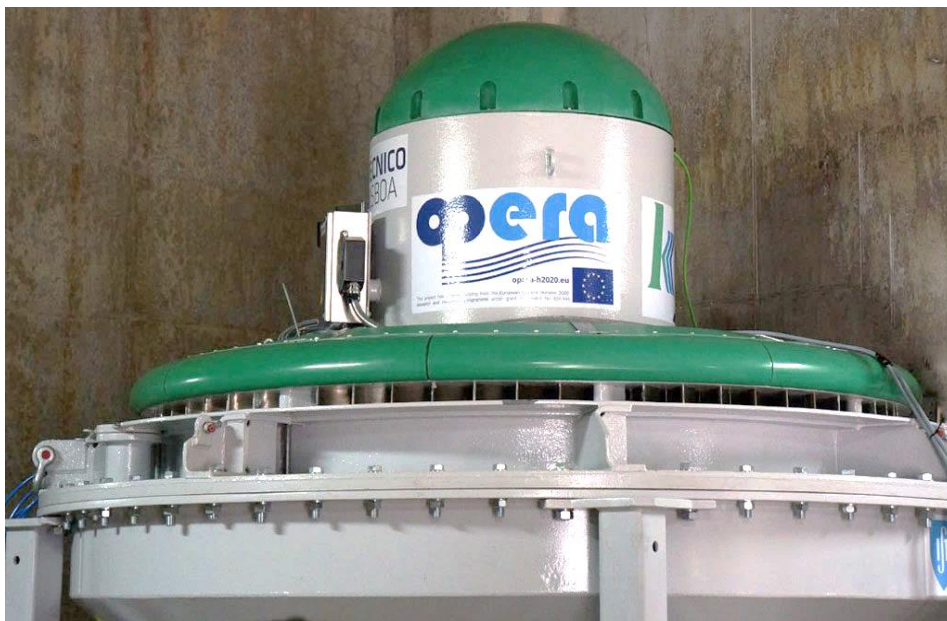
FIGURE 24. BIRADIAL TURBINE PTO OPERATING AT MUTRIKU.

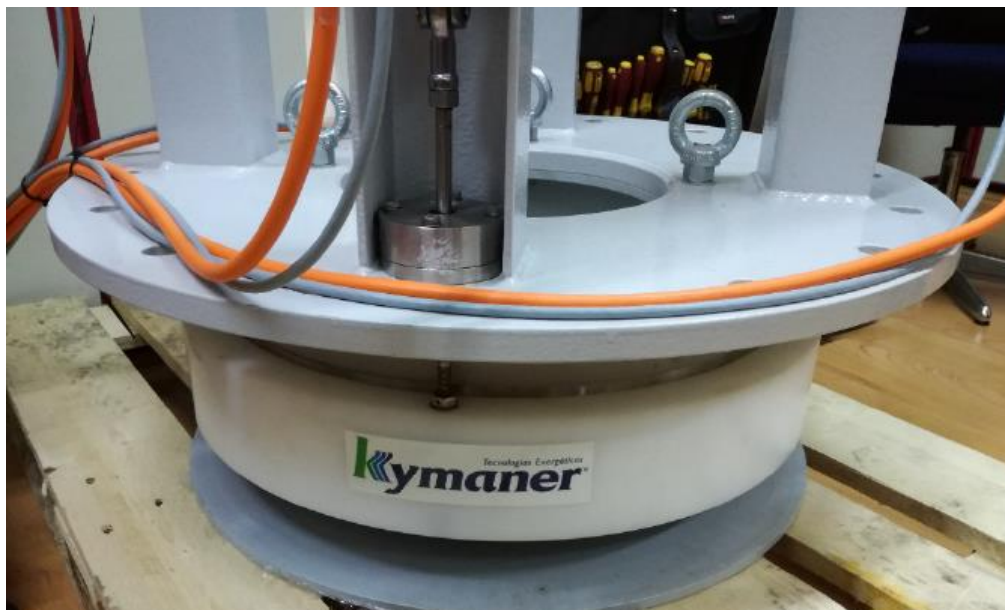
The integrated high-speed safety valve (HSSV) consists of a cylindrical shutter that operates within a short stroke (~60 mm), closing the passage of one of the Biradial turbine ducts. The position of the valve allows a double function to be explored: limit the energy available to the turbine-generator set, protecting it in case of storm conditions by controlling runaway speed and latching control.

**FIGURE 25. HIGH-SPEED SAFETY VALVE (HSSV) DURING PRELIMINARY TESTING AT KYMANER.**

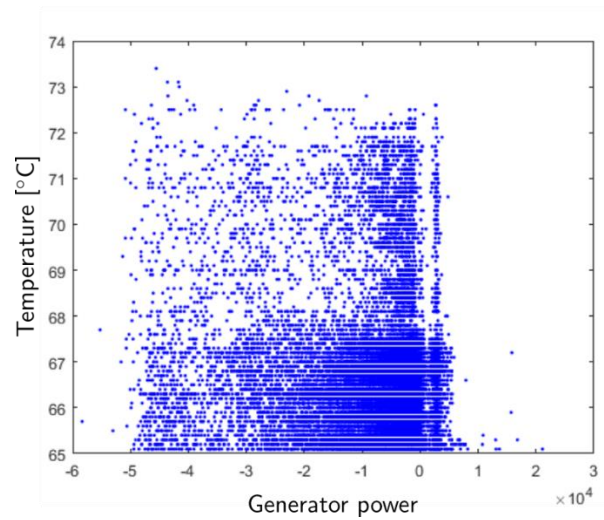
Relating to the electric generator, the temperature of the stator windings has not suffered wide thermal cycles. Besides, its isolation was defined as Class H (see Tab. 2), withstanding so with temperatures until 180°C. As it is shown in Figure 27, the temperature did not exceed 74°C in any case.

**FIGURE 27. HIGHER TEMPERATURES REGISTERED IN STATOR WINDING AS FUNCTION OF THE GENERATOR POWER.**
