Open Sea Operating Experience to Reduce Wave Energy Costs

Deliverable D1.2

Mutriku and BiMEP operating data collection experience

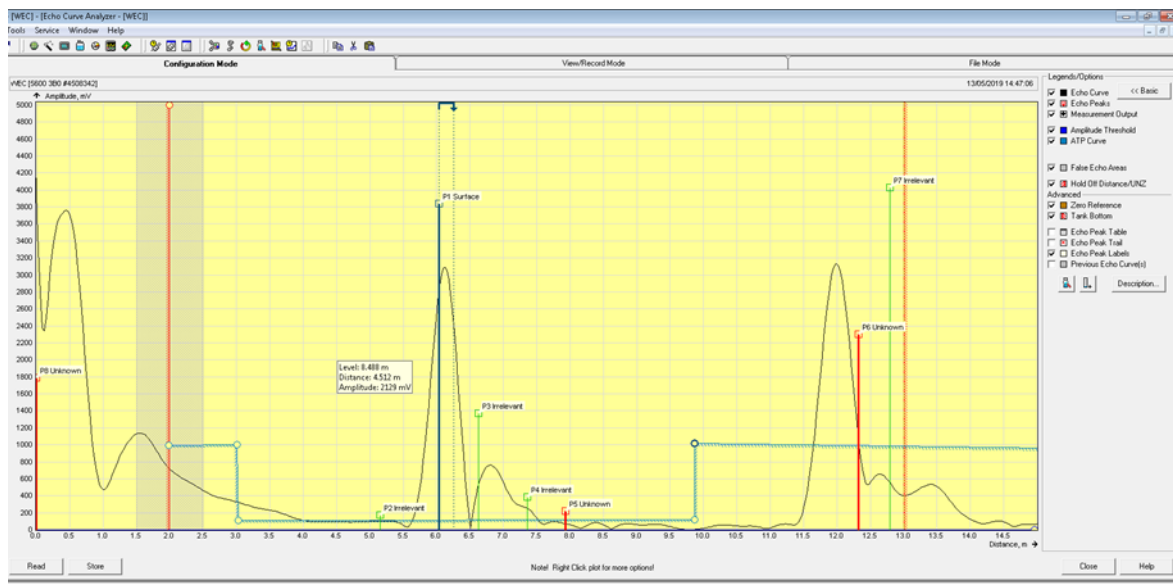
FIGURE 2-2: ECHO CURVES FOR RADAR LEVEL METER

Figure 2-4 show a typical echo curve of such types of sensor, with echo peaks intensity plotted against echo travel distance. The particularities of the chamber geometry, with a very flat and reflective bottom, produced a double bounce of the echo that must be filtered to have a good reading. Also, a hold-off distance had to be considered to avoid the perturbations produced by the signal traveling through the orifice hole of the chamber ceiling to reach the internal air chamber.

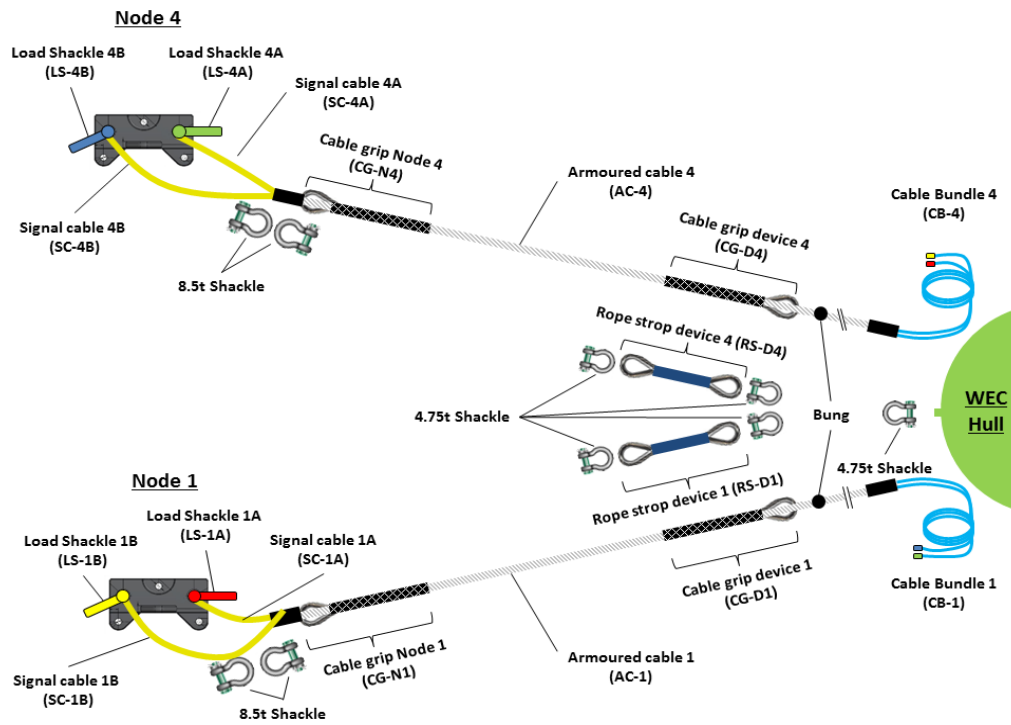
FIGURE 2-4: SCHEMATIC OF THE LCS WHERE THE POSITION OF LOAD SHACKLES IS DETAILED

To validate the effectiveness of the new mooring design, the force in the tethers has been monitored during this test period. For this purpose, four load shackles were installed in the node that connects the catenary and the conex. Unfortunately, the electrical cables of the load shackle broke about approximating one month after their installation.

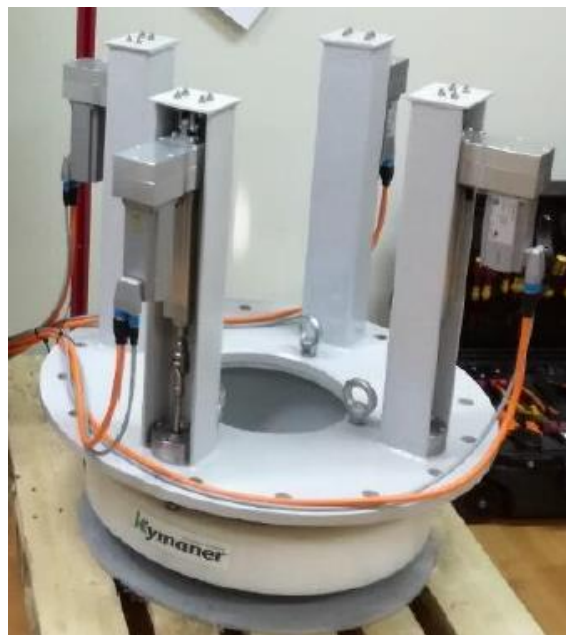
FIGURE 2-6: HSSV VALVE ACTUATORS AND VALVE ANNULUS DURING CONSTRUCTION

The commissioning of the new turbine in Mutriku required an effort bigger than expected due to some problems in the valve control. The start-up procedure presented spurious failures. Because this situation was not adequately managed by the valve controller, the safety procedures were not adequately passed to the plant controller, leading to unsafe operation of the valve.

During the last period of tests, some hardware failures were also detected, where some actuators would randomly raise errors and trip either during their homing process or during valve operation. Further investigation showed that hardware errors were caused by the faulty valve connectors. The connectors of the actuators are very fragile considering the harsh environment where they must operate, especially the encoder connectors. The connector plug-in process, even if carried out carefully, can result in damage in the actuators connectors. A more robust actuator should be chosen for this application in next designs.

of the testing campaign in Mutriku, where some failures in the actuators eventually stopped the valve and prevented the system to open/close. Moreover, the system would halt whenever the error was raised, nullifying the safety close procedure and then leaving the air passage to the turbine wide-open.

- First, a thorough refurbishment of the valve actuator was performed, and replacement of a motor was done, while the turbine was on the workshop and prior to its installation in the buoy.

- Second, a command signal was integrated in the PLC that would send a close order to the actuator in case of failure. Unfortunately, this would not avoid the HSSV to get stuck in an open position if an electric failure occurs. Mutriku chamber was equipped with a safety valve with a ballast that would close the air flow to the turbine if a failure occurred. However, the buoy is not equipped with such a protection system due to the strong dynamic effects the ballast would produce in the buoy.

Furthermore, the software in the HSSV controller was revised by IDOM to identify critical points that would make the HSSV not reliable. The initialization process was extended to identify possible causes of valve obstruction. The error interface with the PLC was further extended to incorporate diagnosis information that may help identifying unsafe situation in the plant controller. It was also identified that the valve required the four actuators to be operation in order to adequately close the air flow. Nevertheless, the risk finally materialized when failure in valve initialization, and the HSSV commissioning delayed the start of the test campaign.

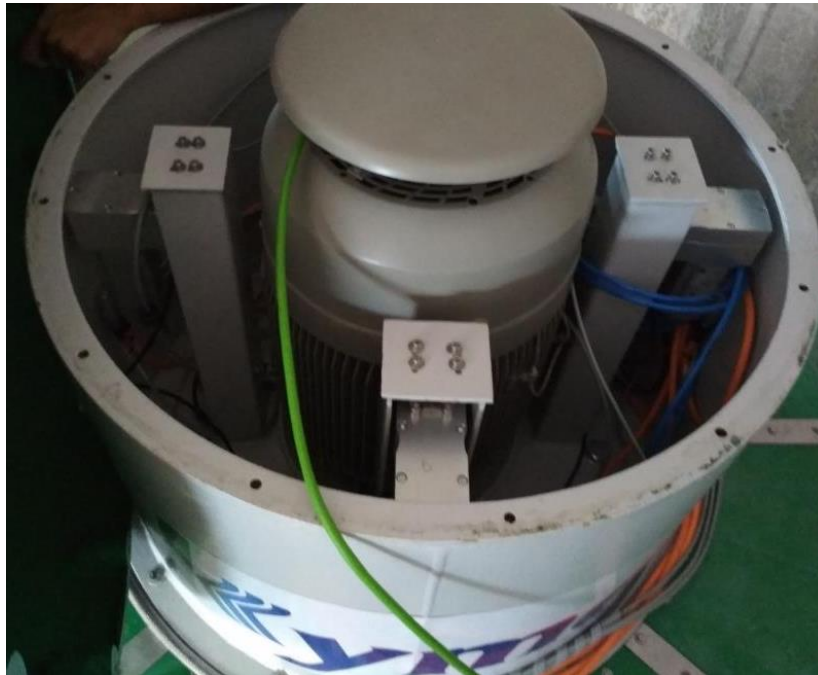
FIGURE 2-13: SIEMENS IM GENERATOR INSIDE THE TURBINE NACELLE

A fault in the generator caused an early damage in the machine on September 2017 that ultimately led to stopping the test until the problem could be solved. The installed generator was not equipped with the correct degree of electrical insulation protection of the stator, which is typical of applications where the motor is fed by a Variable Frequency Drive.

The isolation of the stator could not cope with the chopped power input of the machine and a shortcut damaged completely the stator of the motor. Two actions were taken to deal with this problem:

The integrity of the generator during the offshore test campaign raised some concerns, being a component that had already suffered a failure in Mutriku. The risk that the generator could suffer a second insulation failure persisted, as the sufficiency of the LC filter to prevent this from happening remained unclear.

- On one side, a new stator was reinstalled in the generator. This new stator incorporated a reinforced insulation to avoid possible new damages produced by the same cause. The procedure of extracting the generator from the turbine and reinstalling it in its position was a complex task, due to the tight fitting of the generator inside the HSSV supporting structure.

Due to the impossibility of implementing a closed loop control, a scalar open loop v/f control have been installed to control the generator in series with the filter. This kind of control reduced the performance compared to the closed loop FOC control. Nevertheless, the main objective of these tests is not only to validate performance of the turbine but also to compare different high-level control strategies programmed in the PLC. These tests could be carried out with this new deployment.

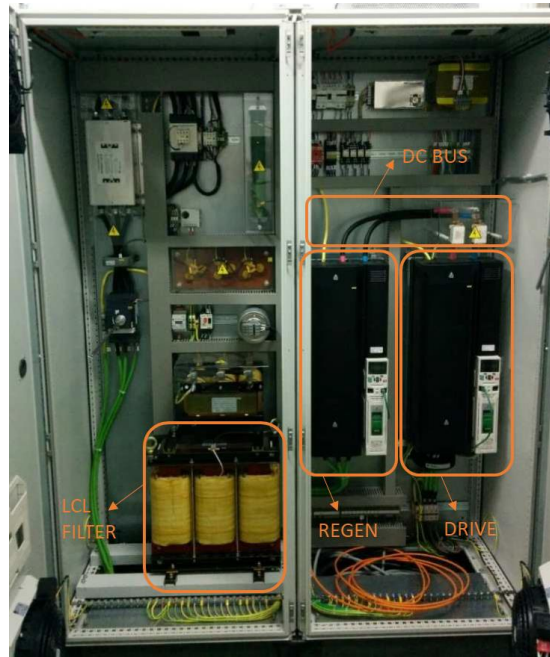
FIGURE 2-16: POWER ELECTRONICS CABINET

The power electronics worked perfectly during the Mutriku test campaign. However, uncertainties in the power measurement resulted in significant extra effort in assessing the real electrical magnitudes coming from the generator mounted in the biradial turbine. The measurements by the Unidrive are not accurate, as they are only intended to represent approximate values, and incorporates significant errors depending on the load applied.

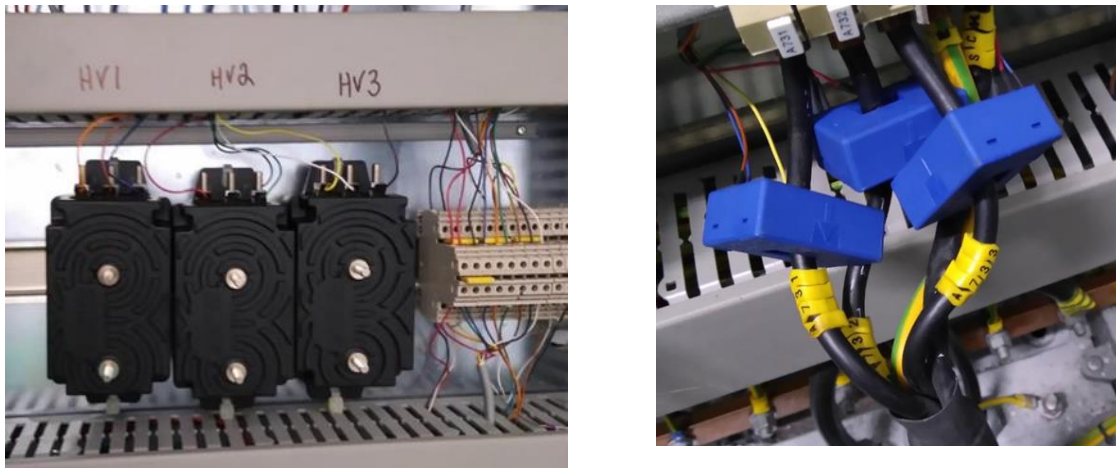
FIGURE 2-18: VOLTAGE (LEFT) AND CURRENT (RIGHT) SENSORS AS INSTALLED IN MUTRIKU

The voltage and current transducers were retrofitted into the already operational MWPP, and there were difficulties with the physical placement of the current transducers due to space and wiring requirements. Ideally, the voltage and current measurements for the application of IEC 62600-30 should be taken after the RFI filter that is used to remove the high frequency signal generated by the VFD in renewable energy generation systems. Unfortunately, the space and wiring requirements forced the installation of the transducers between the RFI filter and the grid-side VFD, and this influenced the results of the testing. FIGURE 2-19 is a single line diagram for an individual DC-Bus of the plant, which shows the ideal placement of the voltage and current transducers in green and the actual placement of the voltage and current transducers in red.

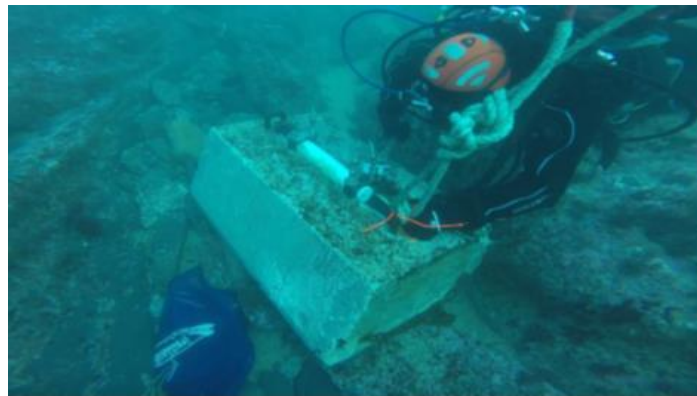
FIGURE 2-23: DIVERS INSTALLING THE UNDERWATER PRESSURE SENSOR

Installed in November 2016 (FIGURE 2-23), 200 m in front chamber #9, following the most frequent wave direction, in a depth of around 15 m. It was removed in May 2017, but a leakage in the battery happened in February leaving only three months of viable data.
